# Optical inspection of the new SBS GEMs readout boards

Kondo Gnanvo

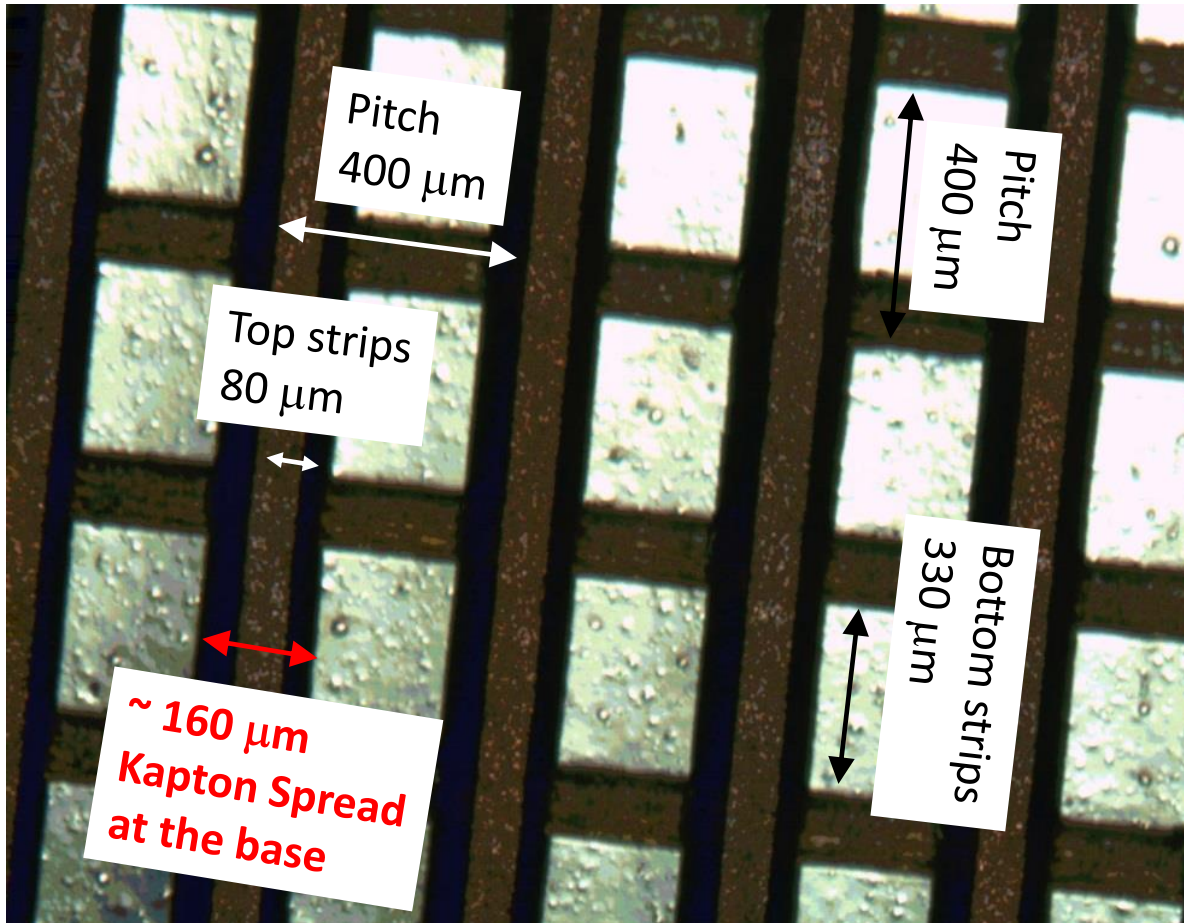
Microscope view of the pre-R&D SBS readout board (batches: before February 2014) showing extra Kapton extending out from under the readout strips. This defect is believed to have caused the uneven charge sharing observed in the pre R&D chambers

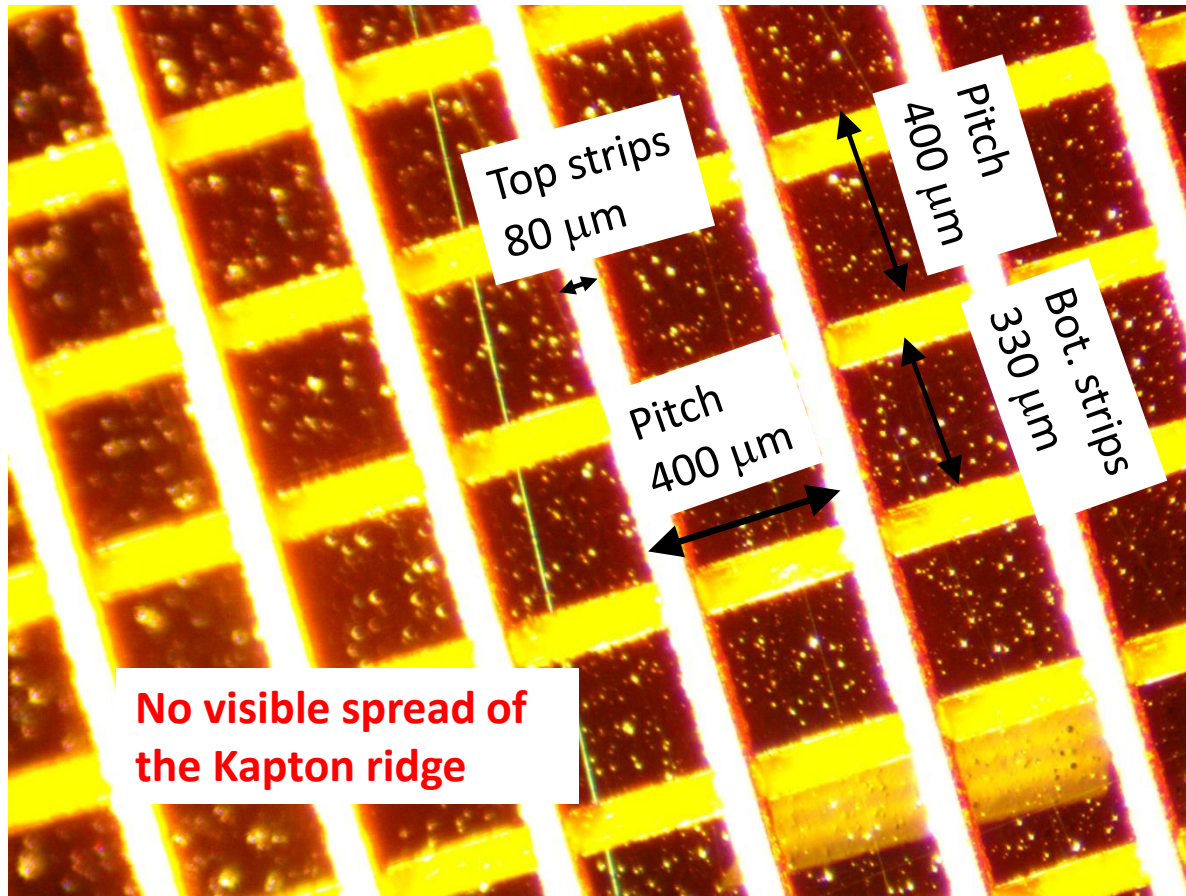
- Microscope view of the production SBS readout board (first production bath April 2014) showing no Kapton extending out from under the readout strips
- Inspection of 3 readout boards

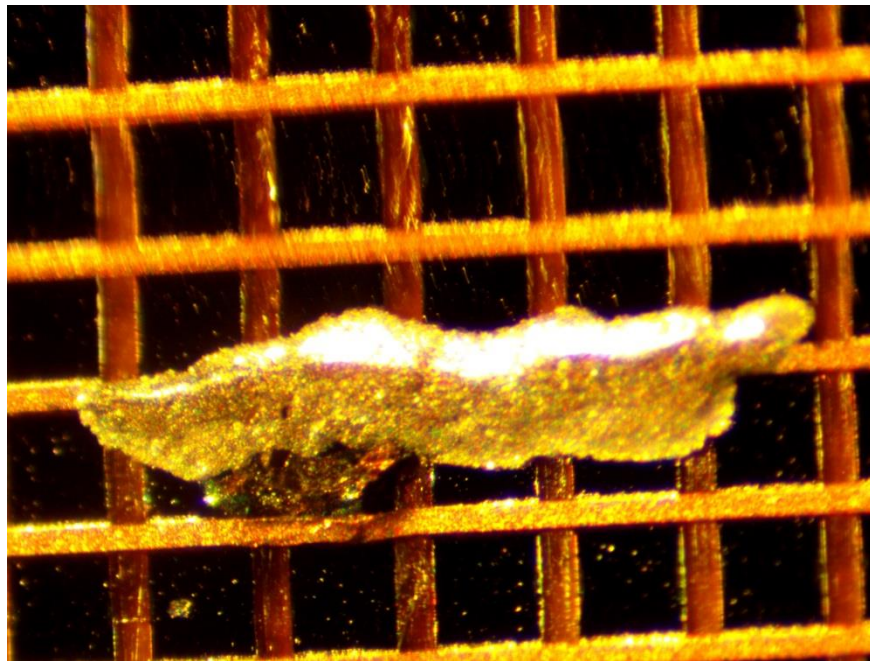
- Small number of broken strips during production;
- in general Rui's procedure is to fix it is to apply a conducting paste by hand (see picture)
  - We feel that it is better not to do this, So we ask Rui not to fix the broken strips
